Vegetation Impacts of Ice Roads and Pads— Lessons Learned from Case Studies

Janet Kidd

ABR, Inc.—Environmental Research & Services

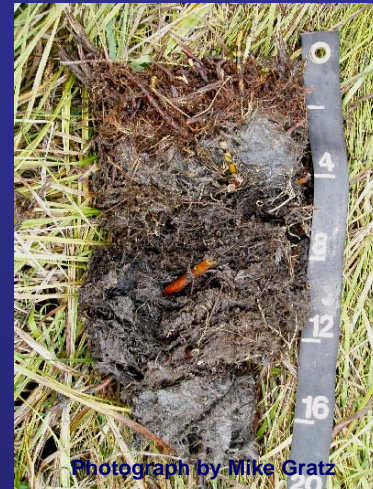
Histic
Epipedon

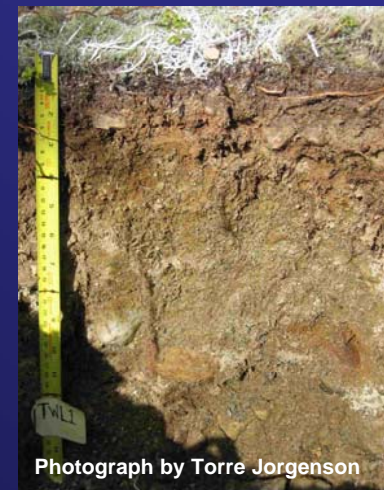
Typic
Dystrocryept

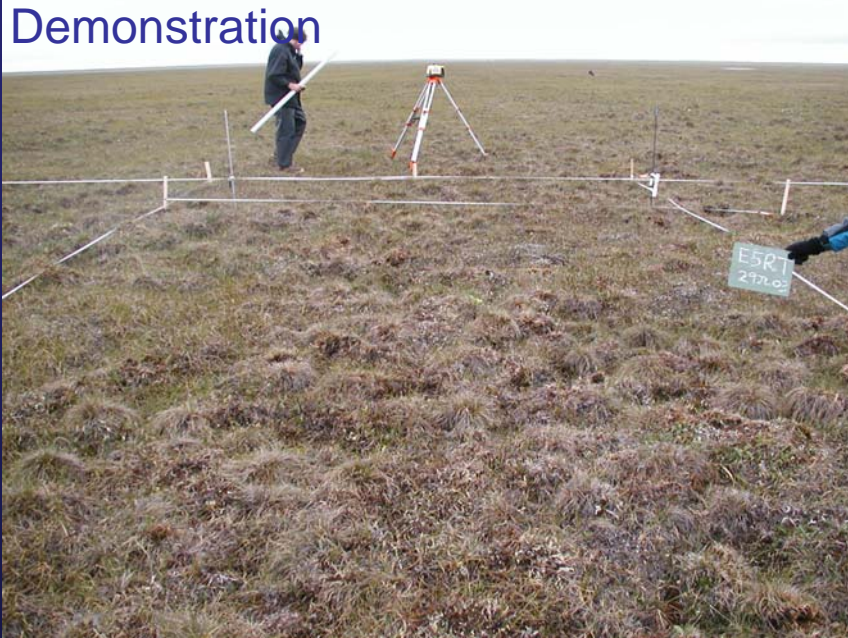
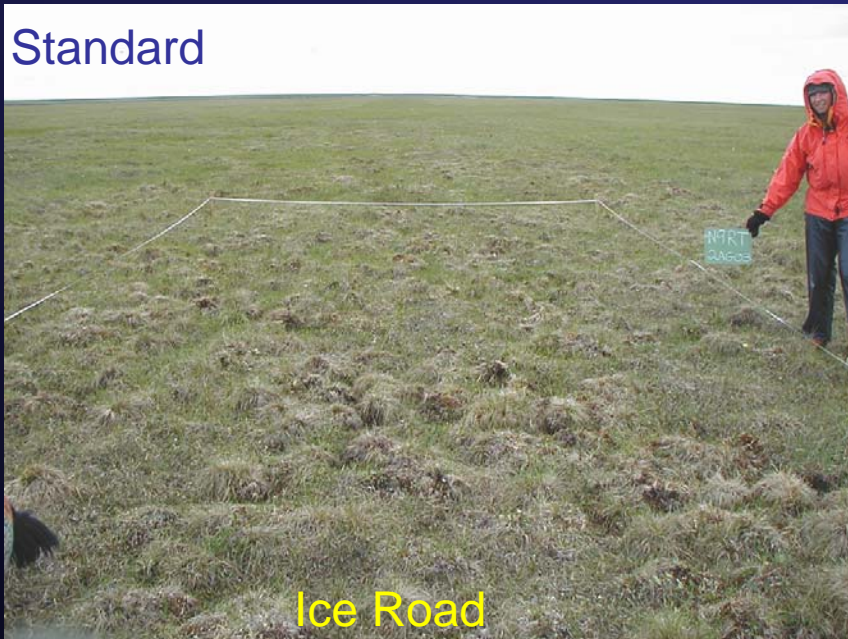
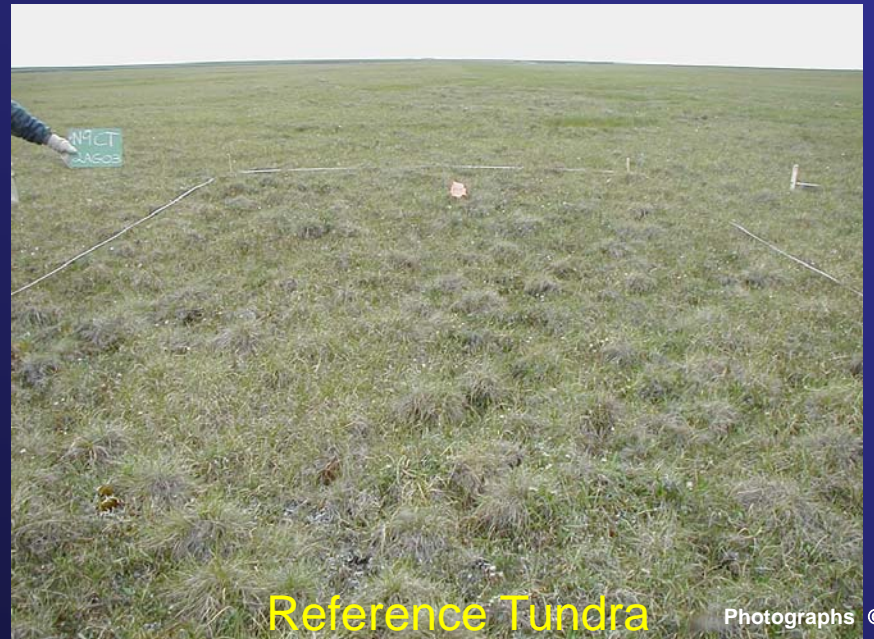
Tussock Tundra Plots

Demonstration

Standard

Ice Road

Reference Tundra

- Total live cover was similarly reduced in both road segments compared to reference tundra.
- Reductions in vegetation cover were more pronounced for tussock tundra and moist sedge-shrub tundra than wet sedge tundra
- Main differences between the two ice road segments was significantly ($p = 0.001$) lower cover of evergreen species and significantly ($p = 0.02$) higher cover of bare soil in the standard segment compared to the demonstration segment
- Overall cover of bare soil, however, was very low ($< 2\%$) in both road segments.

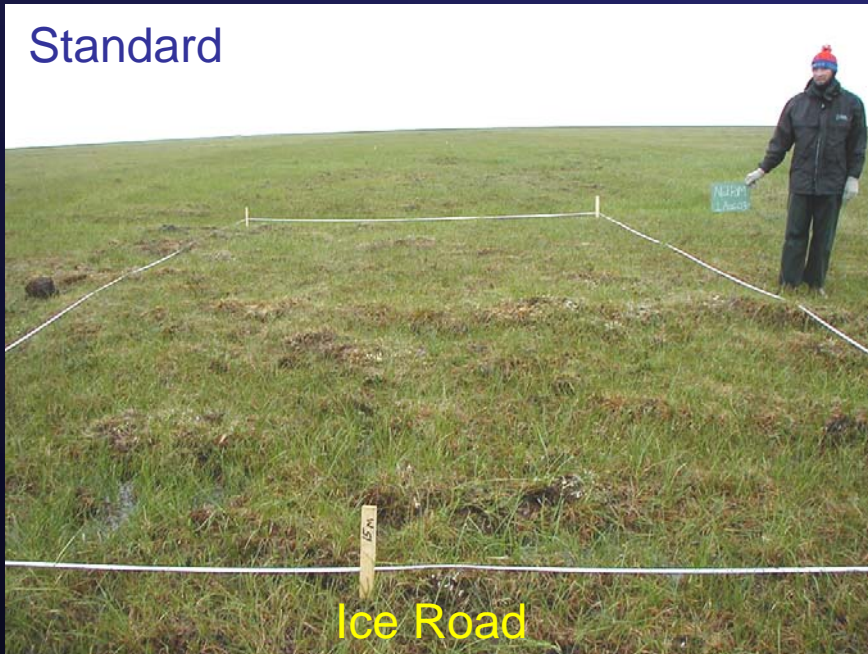
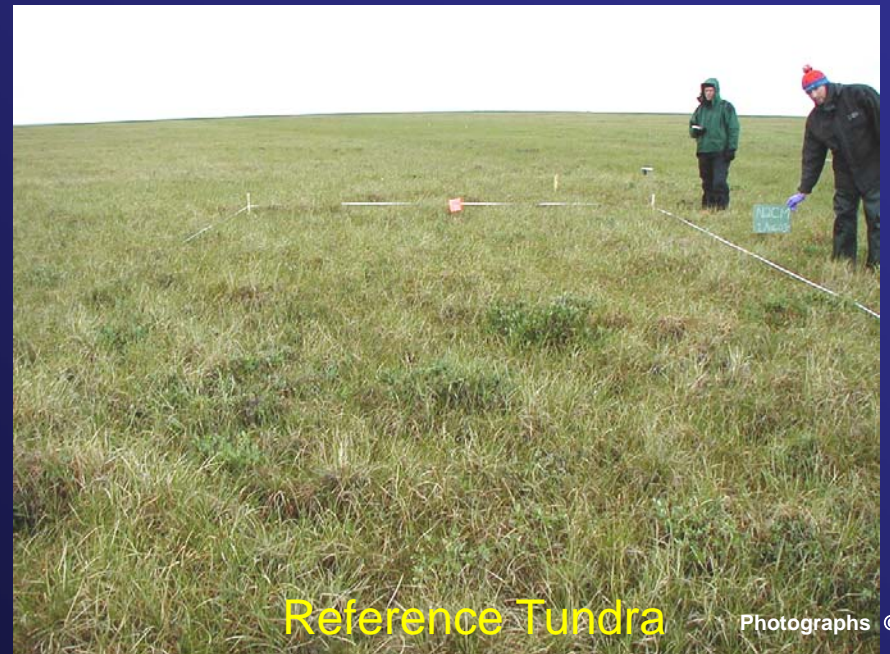
Moist Tundra Plots

Demonstration

Standard

Ice Road

Reference Tundra

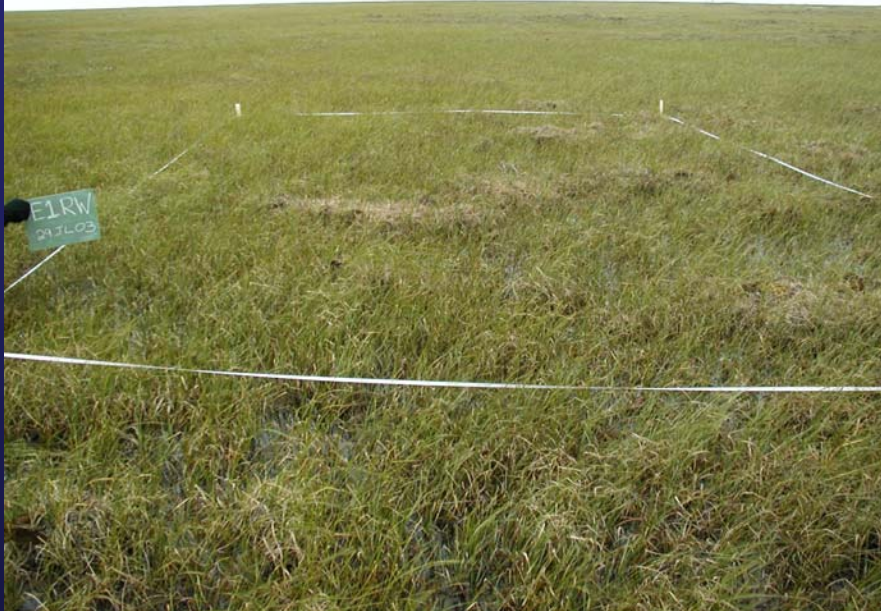
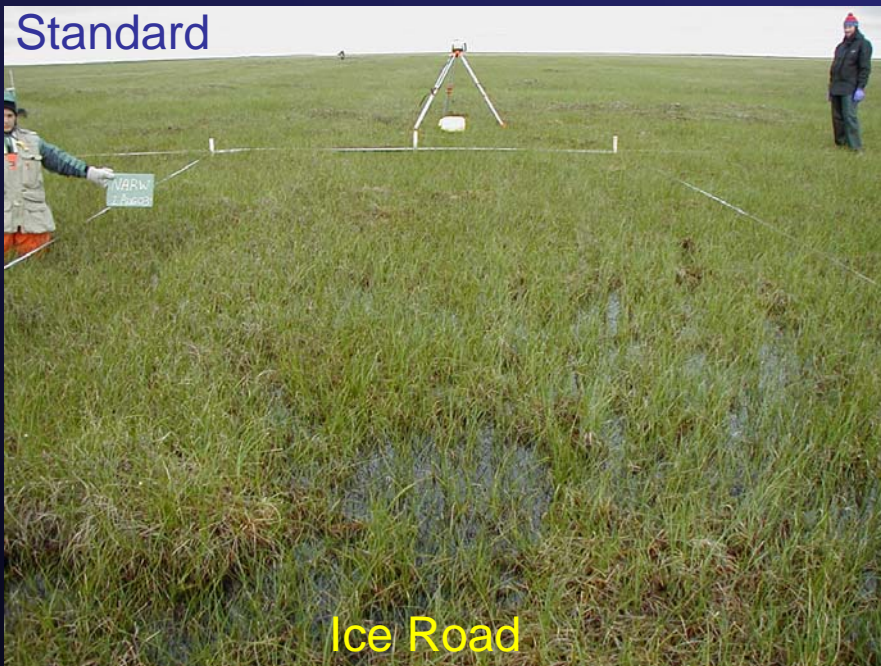
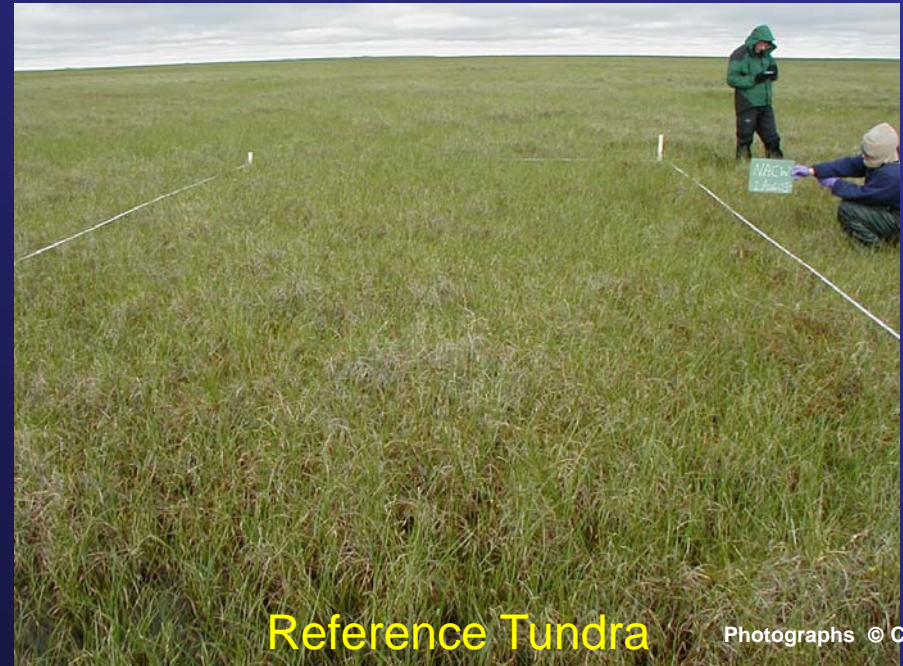
Wet Tundra Plots

Demonstration

Standard

Ice Road

Reference Tundra

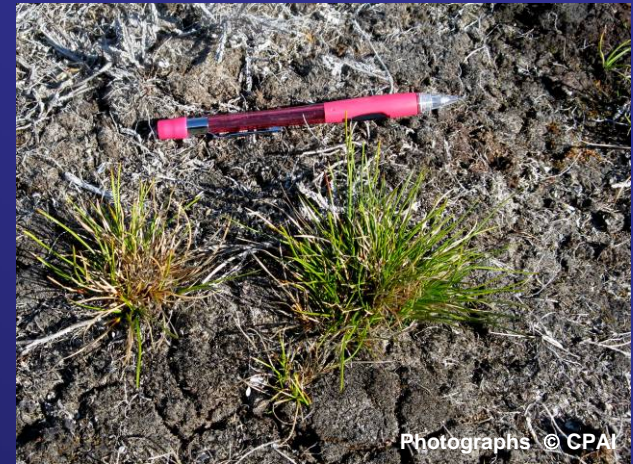
Tussock seedlings; 2008

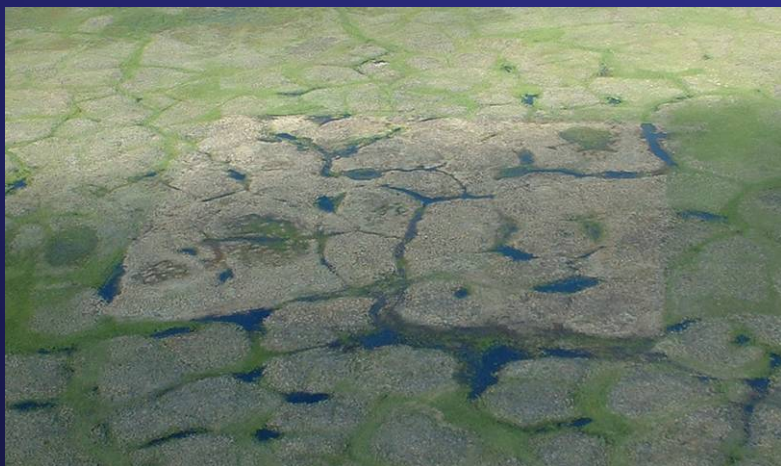
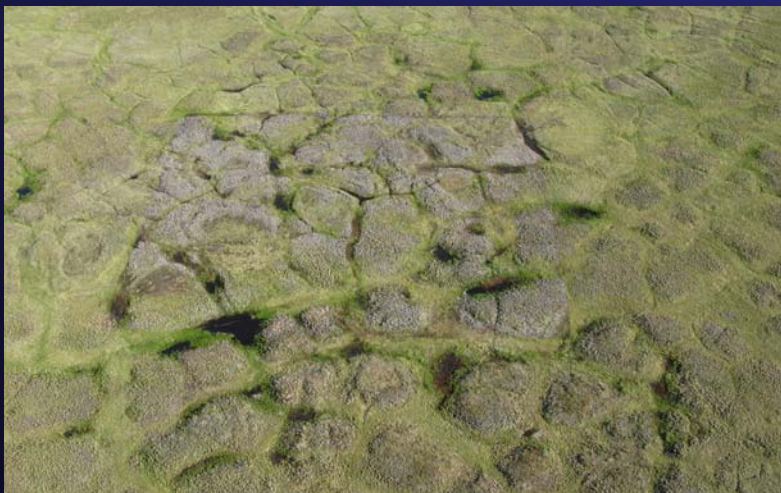
- Thermokarst and subsidence have occurred in some polygon troughs, but there has been little visible change in these areas since 2004.

2003

2008

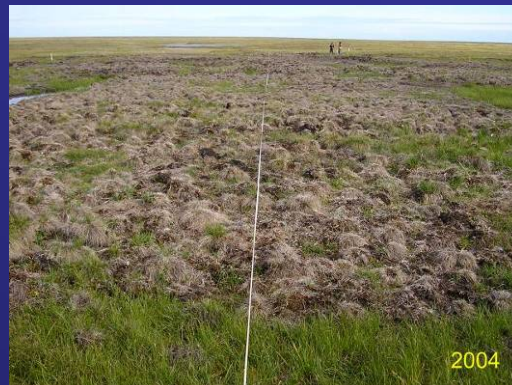
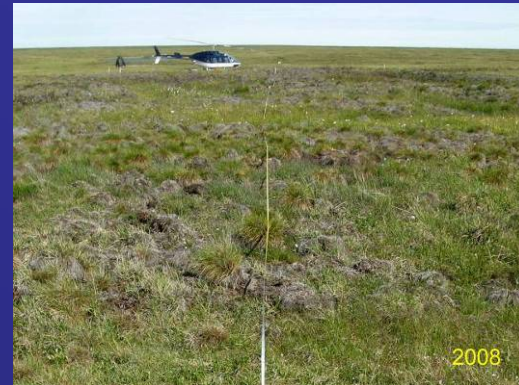
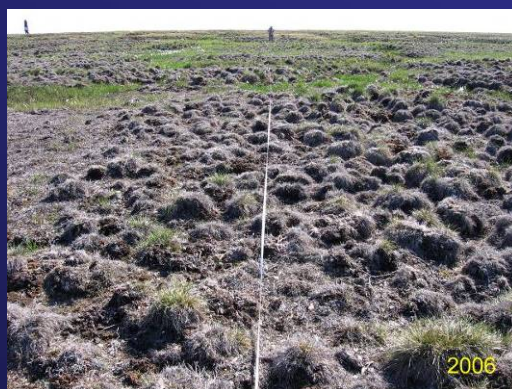
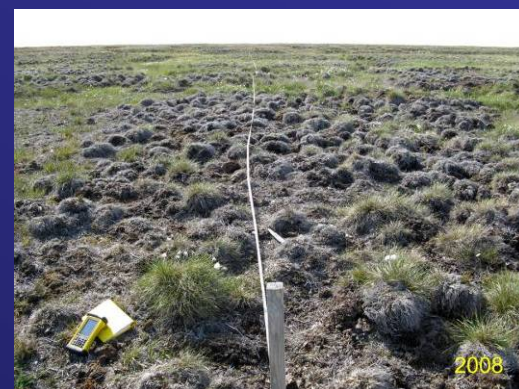
2004

2008

2006
